**PHOTOGRAPHIC
INTERPRETATION
REPORT**

**ECONOMIC RECONSTRUCTION IN
BANGLADESH SINCE THE
DECEMBER 1971 WAR**

JANUARY 1973

PIR-002/73

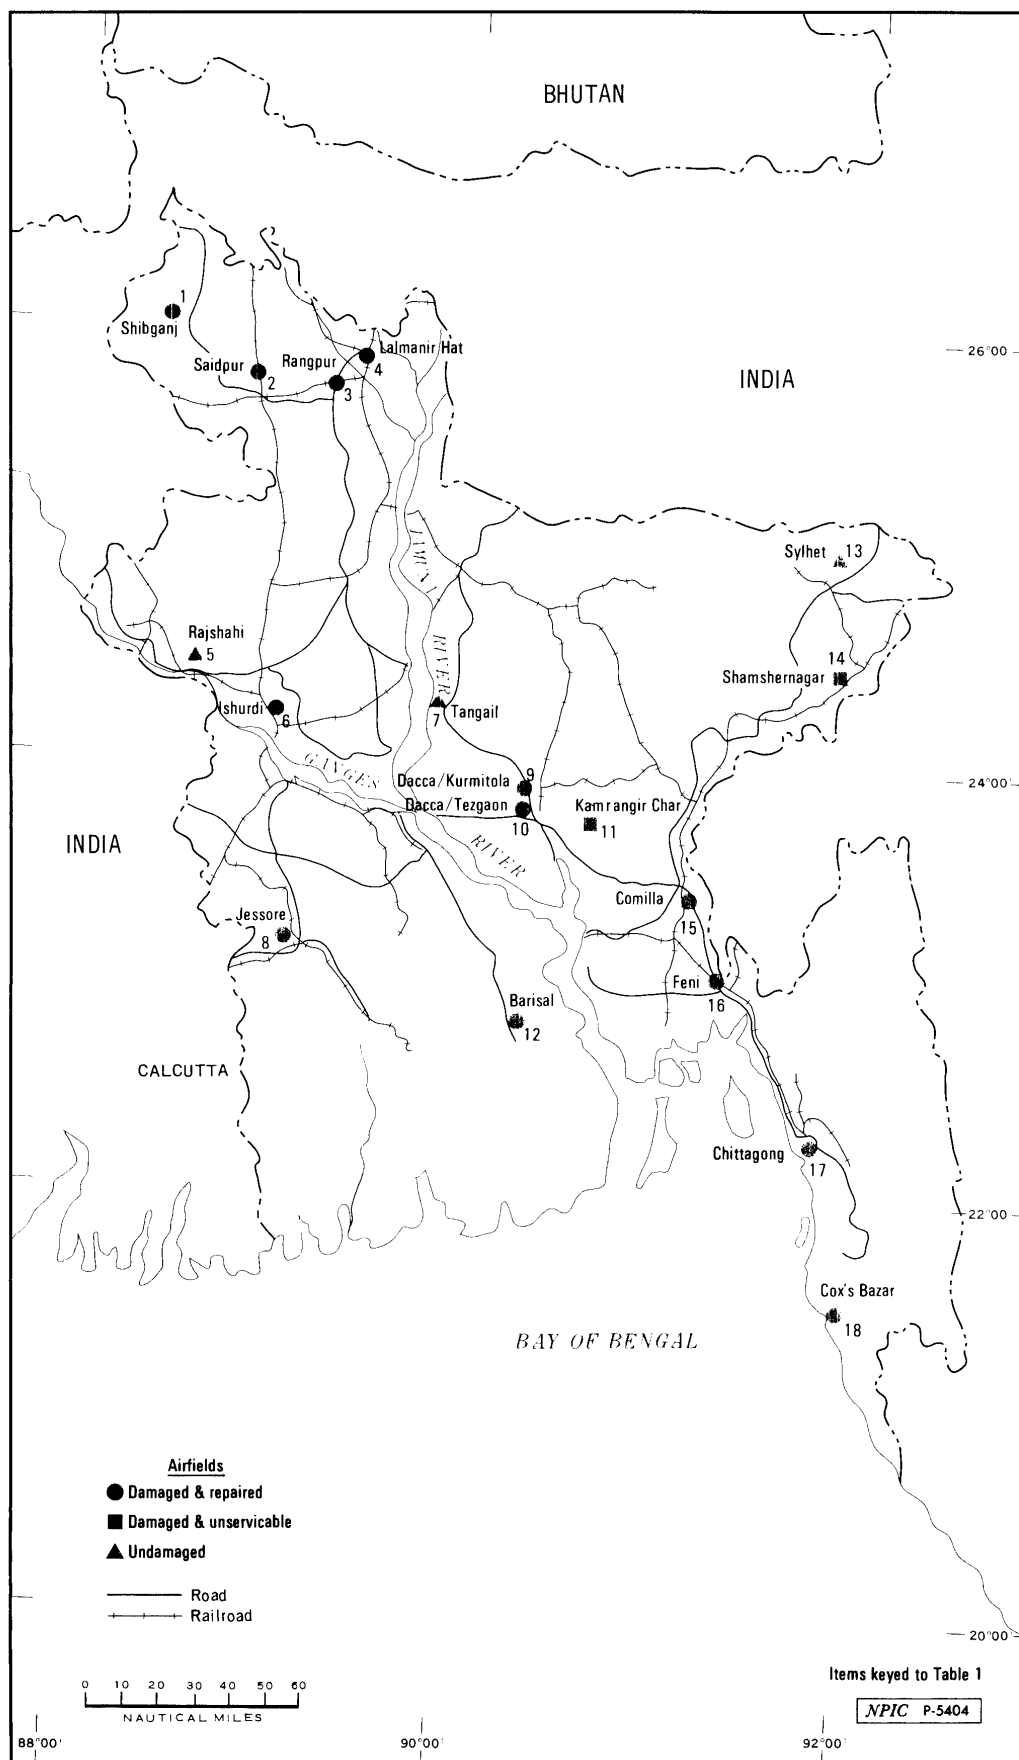
FIGURE 1. AIRFIELD STATUS, BANGLADESH

4. There are 18 airfields in Bangladesh. Fifteen of these suffered bomb damage. All but two of these have now been repaired giving the country 16 serviceable airfields (Figure 1 and Table 1).

Name	Coordinates	Status
Dacca/Kurmitola (9) (see Figures 4 & 5)	23-50-20N 090-24-03E	Repaired and serviceable
Dacca/Tezgaon (10)	23-46-45N 090-23-03E	Repaired and serviceable
Jessore (8)	23-10-52N 089-09-50E	Repaired and serviceable
Comilla (15)	23-26-15N 091-11-32E	Repaired and serviceable
Sylhet (13)	24-57-30N 091-52-38E	Undamaged
Shamshernagar (14)	24-23-40N 091-55-10E	14 craters on runway unserviceable
Feni (16) (see Figures 2 & 3)	23-02-05N 091-23-58E	Repaired and serviceable
Shibganj (1)	26-01-00N 088-24-10E	Repaired and serviceable
Lalmanir Hat (4)	25-53-20N 089-26-00E	Repaired and serviceable
Rajshahi (5)	24-26-35N 088-37-07E	Undamaged
Saidpur (2)	25-45-40N 088-54-30E	Repaired and serviceable
Rangpur (3)	25-44-55N 089-14-15E	Repaired and serviceable
Tangail (7)	24-13-35N 089-54-35E	Undamaged
Ishurdi (6)	24-09-10N 089-03-10E	Repaired and serviceable
Kamrangir Char (11) (see Figure 6)	23-47-30N 090-38-45E	6 bomb craters on runway - unserviceable

Barisal (12)	22-47-48N 090-18-15E	Repaired and serviceable
Chittagong (17)	22-15-27N 091-49-32E	Repaired and serviceable
Cox's Bazar (18)	21-27-00N 091-58-05E	Repaired and serviceable

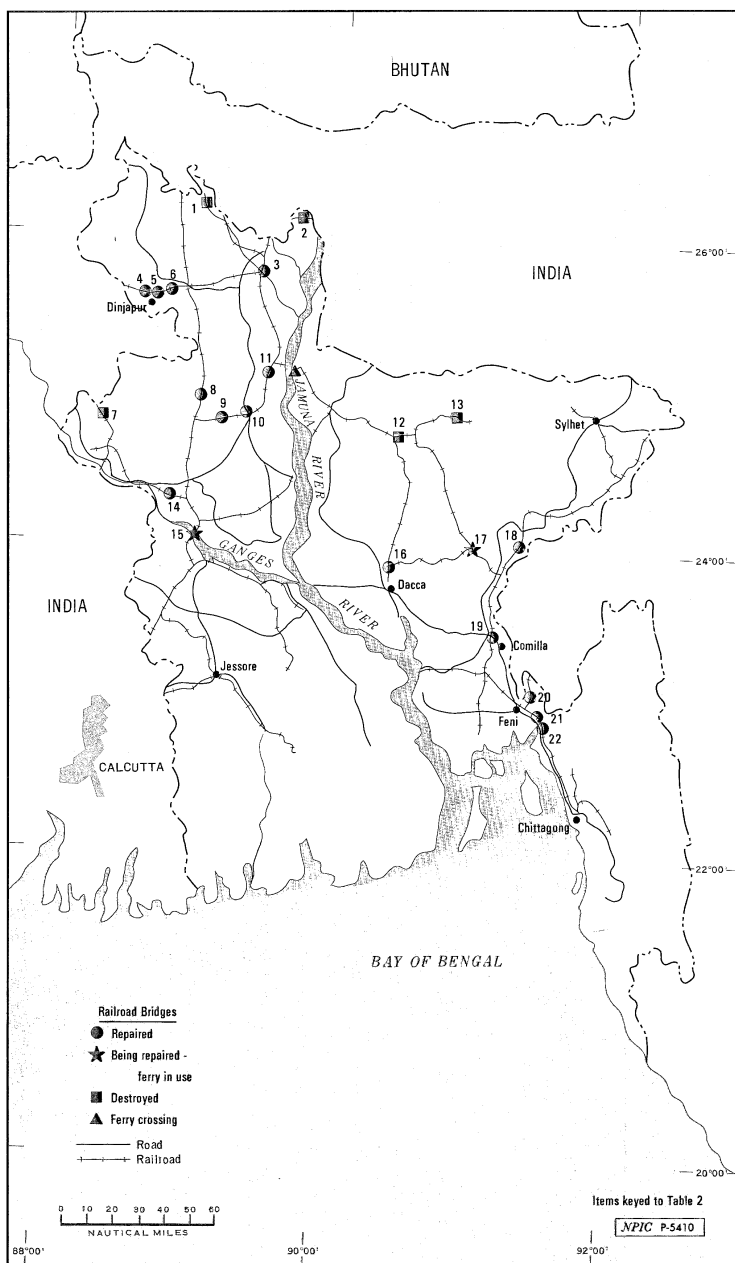
FIGURE 7. RAILROAD BRIDGE STATUS, BANGLADESH

15. Photography [] covered all 20 of the bridges observed damaged on [] and two others in the previously unphotographed area of north-central Bangladesh. All but seven of these 22 bridges are now repaired, including four of the five on the vital Dacca/Chittagong line (Figure 7 and Table 2). The Fozilpur Railroad Bridge over the Muhari River is one of those repaired (Figures 8 and 9). The only bridge on this line not repaired was the Bhairab Bazar Railroad Bridge over the Maghna River (Figures 10 and 11). The dropped spans on this bridge had been removed and repair activity was apparent. The use of a rail-ferry system at this location completes the Dacca/Chittagong line. A similar rail-ferry system is in use at the still unrepaired Shra Railroad Bridge over the Ganges River. Repair of this bridge is nearly complete. No efforts to repair the remaining five rail bridges were observed. Four of these are located at extreme points within the country. The remaining Mymensing Railroad Bridge over Brahmaputra in north-central Bangladesh does not impede cross-country rail traffic (Figure 12).

Name	Coordinates	Status
Mahiganj, over Tista River (3)	25-47-30N 089-26-20E	Repaired and serviceable
Dinajpur, over Purnabhaha Dhao (4)	25-37-18N 088-37-25E	Repaired and serviceable
Dinajpur, over Atrai River (5)	25-36-48N 088-42-00E	Repaired and serviceable
Dinajpur East, over Kakrai River (6)	25-38-30N 088-45-55E	Repaired and serviceable
Akkelpur, over (8)	24-55-52N 089-00-59E	Repaired and serviceable
Vanuan River Tributary Talora, over (9)	24-49-24N 089-11-32E	Repaired and serviceable
Nagar River Bogna, over Karatoya (10)	24-51-02N 089-22-45E	Repaired and serviceable
Abdulpur West, over Barai River	24-17-23N 088-51-35E	Repaired and serviceable
Shra, over Ganges River (15)	24-04-05N 089-02-10E	Repairs nearing completion. Rail ferry in use
Dattapara, over (16)	23-52-54N 090-24-45E	Repaired and serviceable
Tungkhali (Duel) River Bhairab Bazar, over (17)	24-02-38N 090-59-50E	Repairs begun. Rail ferry in use

Meghna River (see Figures 10 x 11)		
Comilla, over (19)	23-29-04N 091-09-57E	Repaired and serviceable
Gumti River Fozilpur, over (21)	22-57-00N 091-30-15E	Repaired and serviceable
Muhari River (see Figures 8 & 9)		
Zararganj, over (22)	22-54-54N 091-31-48E	Repaired and serviceable
Fenny River Bochadaha, over (11)	25-06-42N 089-30-30E	Repaired and serviceable
Bangali River Nidrabad RR Bridge, (18) over stream	24-01-10N 091-18-50E	Repaired and serviceable
Bhurbaria RR Bridge, (20)	23-03-10N 091-25-40E	Repaired and serviceable
Selonai River Jamgram RR Bridge, (1) over stream	26-14-50N 089-05-30E	Entirely destroyed, unserviceable
Bhurungamari, over (2)	26-05-44N 089-43-20E	3 spans destroyed, unserviceable
Raidak River Rahanpur, over (7)	24-49-25N 088-19-10E	13 spans destroyed, unserviceable
Purnabhaha River Mymensingh, over (12)	24-44-32N 090-25-42E	4 spans destroyed, unserviceable
Brahmaputra (see Figure 12)

Netrakona RR Bridge (13) over stream	24-54-40N 090-49-47E	1 span destroyed, unserviceable

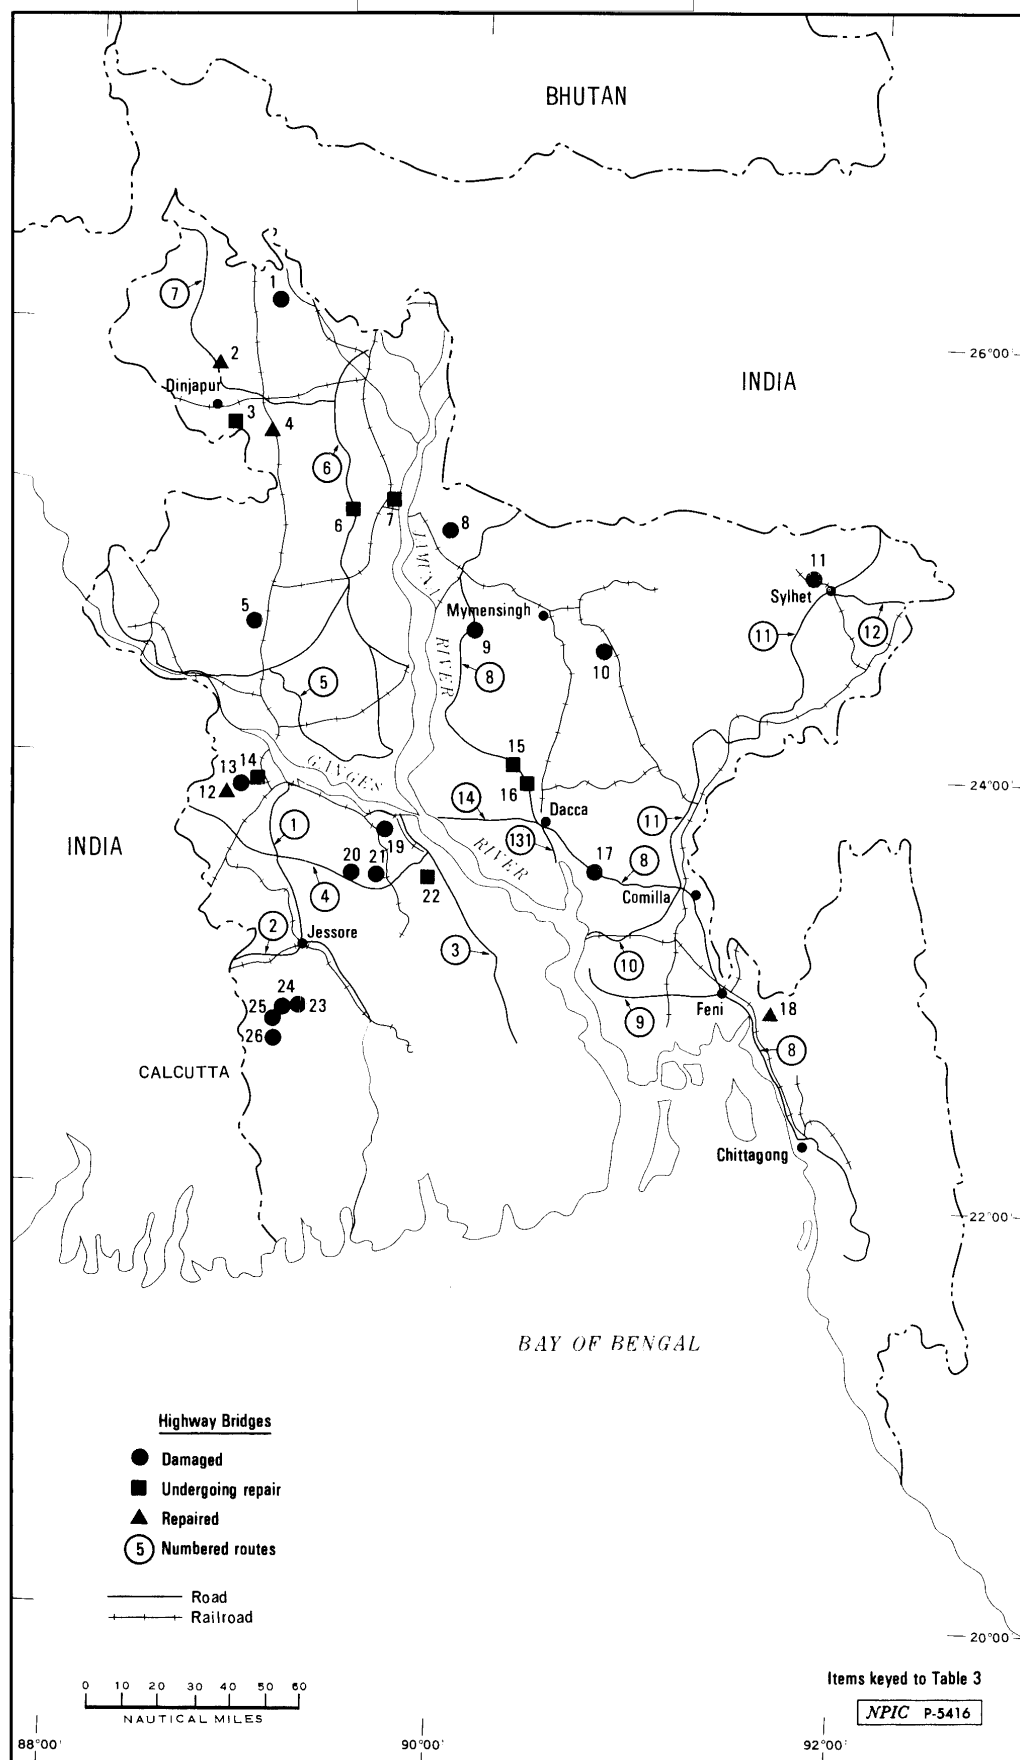
FIGURE 13. HIGHWAY BRIDGE STATUS, BANGLADESH

16. The already poor highway system in Bangladesh was disrupted by the interdiction of numerous bridges during the 1971 civil war. [] limited reconstruction of some major bridges which had been destroyed. Of the 12 destroyed major bridges observed [] four have been repaired (Figure 13 and Table 3). One of these is the Feni Highway Bridge over the Fenny River (Figures 14 and 15). After the bridge had been repaired, a temporary bridge was removed. Three of the remaining eight bridges were under repair and fords or ferries were in use at most water crossings where the bridge

Name	Coordinates	Status
Dinajpur, over (2) Dhau River	25-48-40N 088-40-50E	Repaired and serviceable, by-pass bridge removed
Dinajpur, over (3) Kakrai River	25-32-20N 088-45-50E	Bridge in late stage of construction
Phurbari, over (4) stream	25-30-00N 088-57-20E	Repaired and serviceable
Attrai, over Gur River (5)	24-36-40N 088-58-20E	Abutment damaged, bridge intact, bridge not in use
Kushtia-Meherpur (12)	23-52-15N 088-47-20E	Repaired and serviceable
Kushtia-Meherpur, (13) over Matabhanga River	23-53-40N 088-52-30E	3 spans destroyed, bridge unserviceable, ford and ferry in use
Kushtia-Meherpur (14)	23-54-20N 088-55-35E	Bridge in late stage of reconstruction
Comilla-Dacca (17) (see Figures 16 & 17)	23-35-10N 090-38-20E	Dropped spans removed. New ferry in use
Sylhet-Kandgaor (11)	24-54-35N 091-44-00E	5 spans removed or destroyed, unserviceable
Kasimpur Highway (16) Bridge North, over Turag River	23-59-35N 090-21-10E	2 spans destroyed, unserviceable. New bridge in final stage of construction

Domar Highway Bridge (1) over Deonia Nadi	26-06-00N 088-46-40E	3 spans destroyed, unserviceable. Ford in use
Feni Highway Bridge (18) over Fenny River (see Figures 14 & 15)	22-57-15N 091-33-05E	Repaired and serviceable, by-pass removed
Faridpur Highway Bridge South (22)	23-32-40N 089-51-30E	Single dropped span replaced by temporary span, ferry also in use
Faridpur Highway Bridge West (19)	23-43-05N 089-36-20E	Six spans destroyed, unserviceable, ford flooded
Magura Highway Bridge (20)	23-30-00N 089-26-30E	Entire bridge is destroyed Temporary bridge south of original, two fords no longer used
Faridpur-Magura (21) Highway Bridge	23-31-50N 089-36-40E	Entire bridge destroyed. Four ferry crossings and a ford north of bridge site
Satkhira Highway (23) Bridge Northeast (see Figure 19)	22-45-00N 089-06-10E	One span destroyed, ferry in use
Satkhira Highway Bridge (24)	22-41-15N 089-02-40E	One span destroyed. By-pass bridge north of original

Satkhira Highway (25) Bridge Southwest	22-38-30N 088-59-25E	All 3 spans of bridge destroyed, foot bridge in use at site
Satkhira Highway (26) Bridge South-Southwest	22-35-00N 089-00-05E	All 5 spans destroyed, foot bridge in use at site
Rangpur-Bogra (6) Highway Bridge	25-10-15N 089-23-28E	Bridge in late stage reconstruction
Gaibanda Highway (7) Bridge South	25-14-25N 089-33-42E	Bridge under repairs
Mymensingh-Tangail (9) Highway Bridge	24-36-13N 090-01-15E	Bridge destroyed, by-pass bridge adjacent to it
Kalliakair Highway (8) Bridge West, over unknown stream	24-05-22N 090-09-10E	Bridge destroyed, by-pass bridge in final stage of constructon
Kishorganj Highway (10) Bridge North	24-31-50N 090-45-15E	Bridge destroyed, bypass in early stage of construction
Dacca Highway (15) Bridge Northeast	23-54-10N 090-14-00E	Bridge destroyed. Ferry in use. Repairing abutments

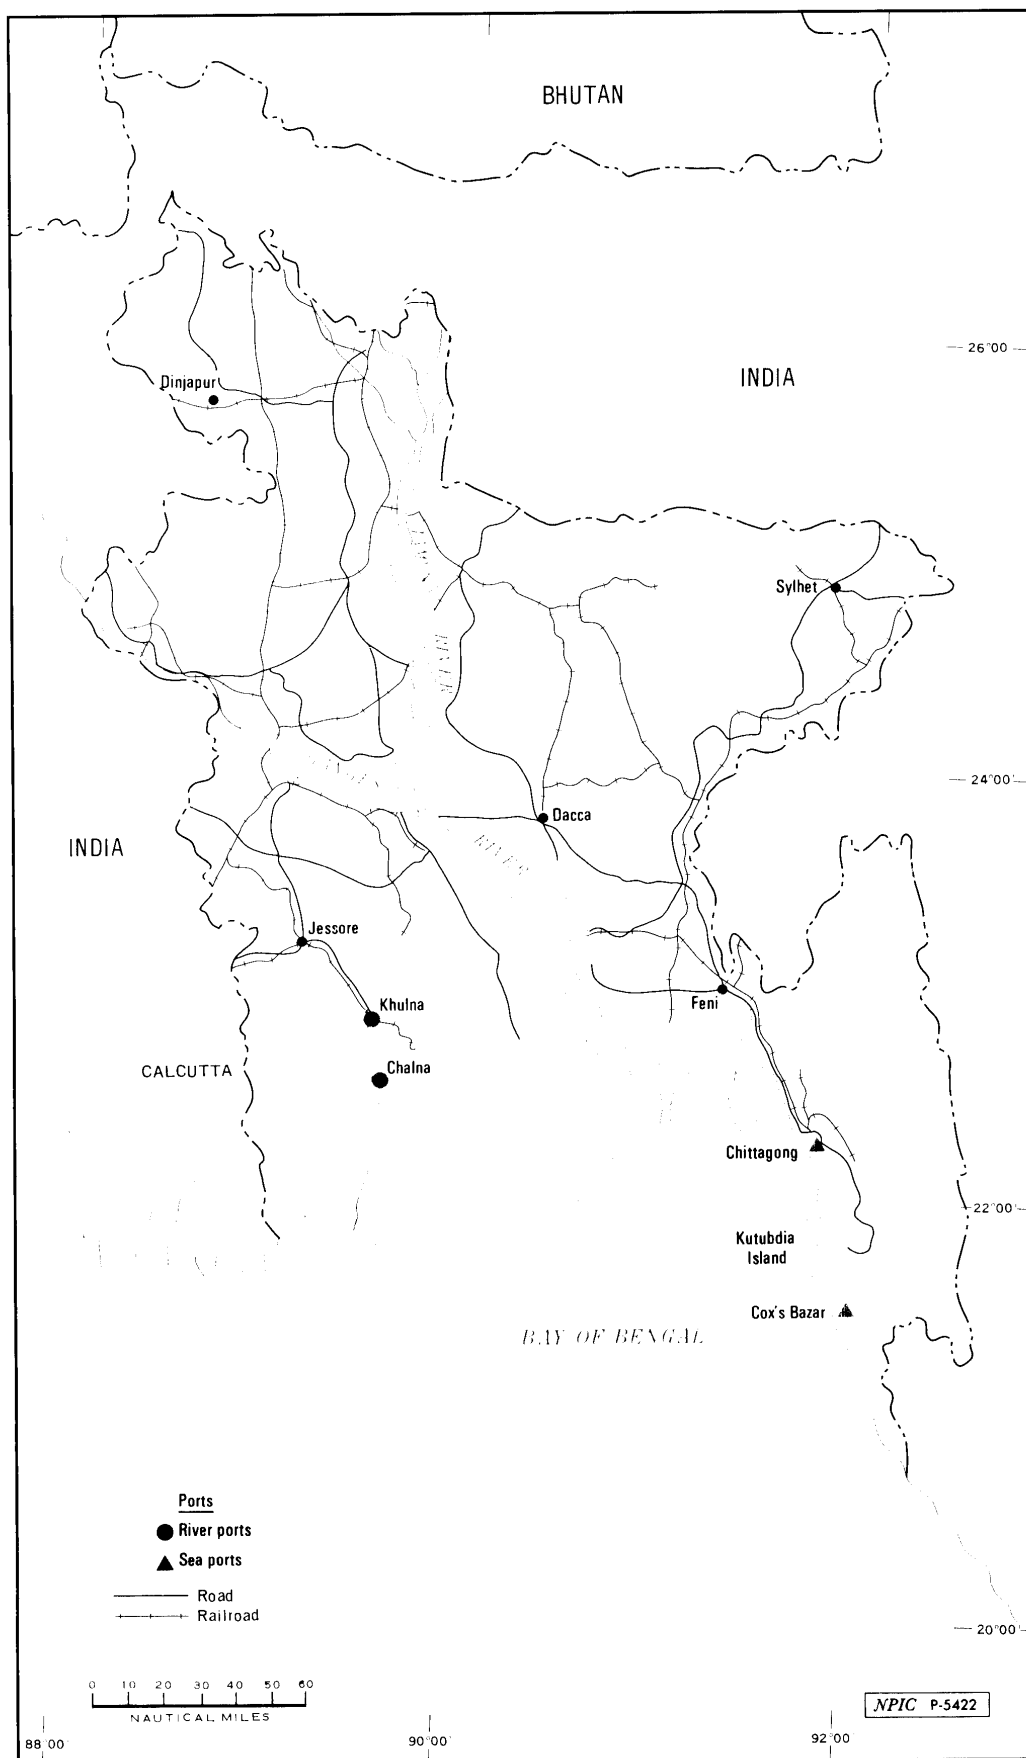
FIGURE 19. PORT FACILITIES, BANGLADESH

18. Ships sunk at Chalna and Chittagong before and during the civil war have hampered the use of these ports in Bangladesh (Figure 19). Navigation into the port of Chittagong was further disrupted by the use of mines in the Bay of Bengal.

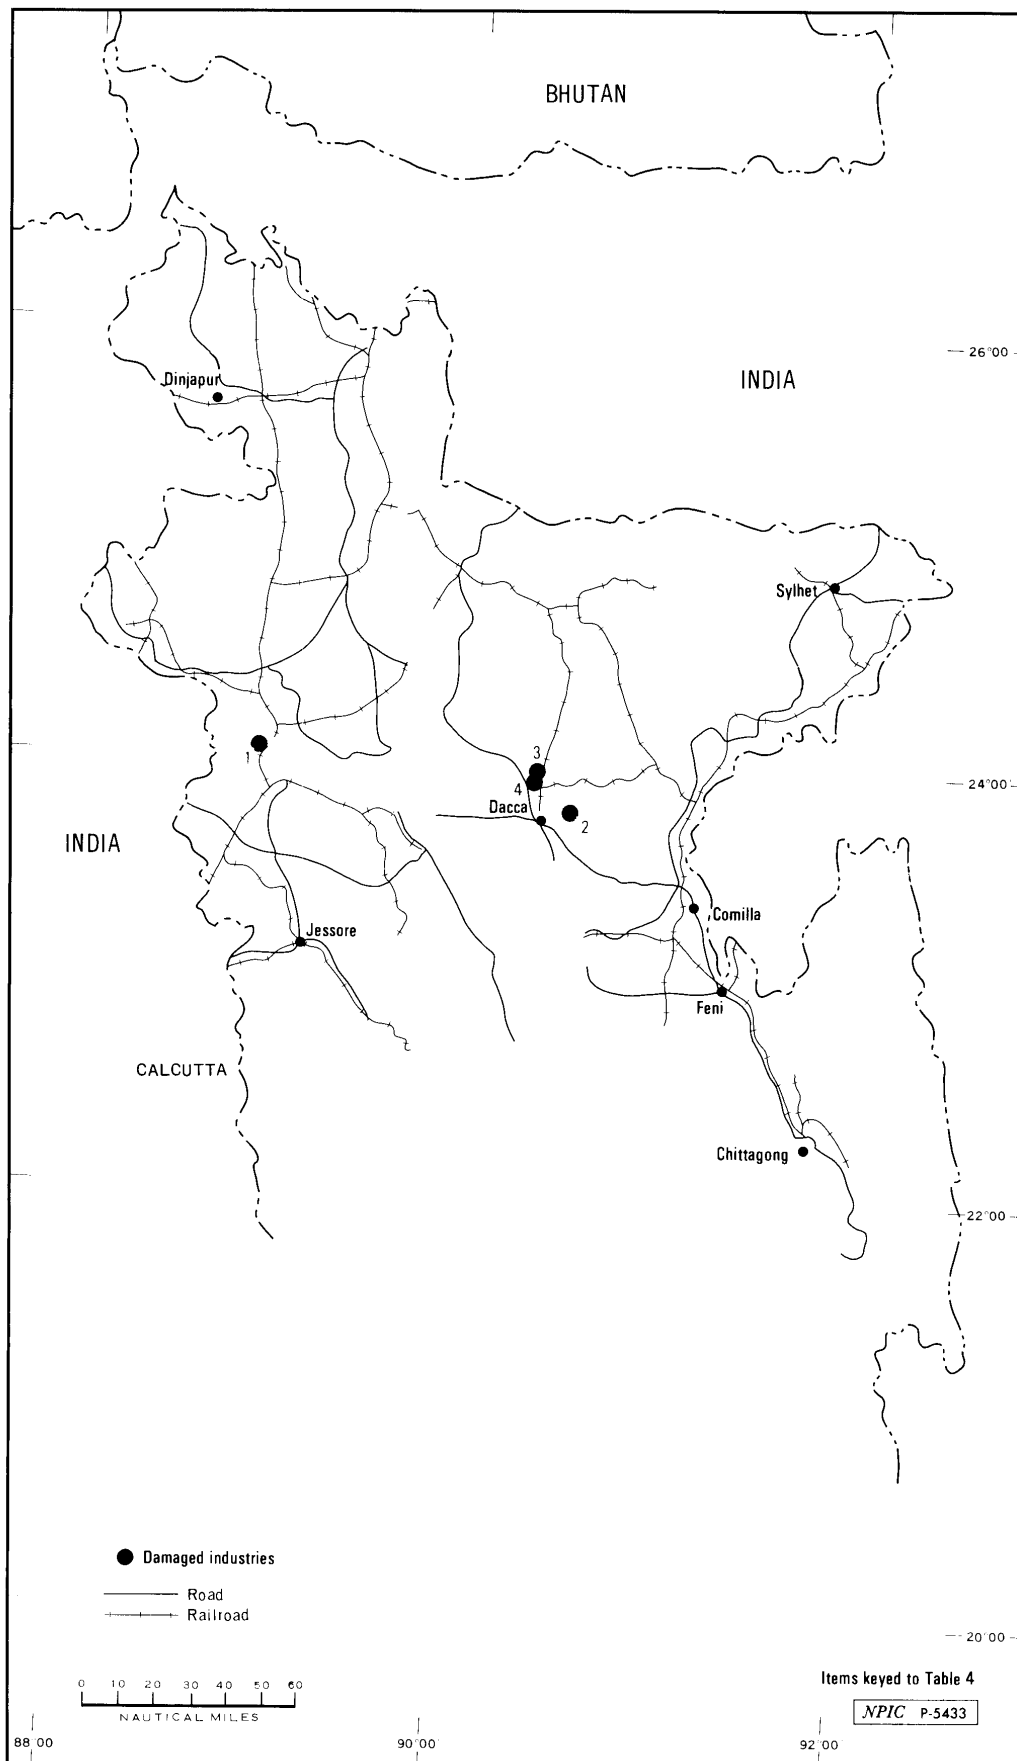
FIGURE 30. INDUSTRIAL STATUS, BANGLADESH

26. The industries in Bangladesh are numerous, but small and widely scattered. Primarily they consist of jute, flour and sugar mills, fertilizer and electric power plants, a cement plant, an ammunition loading plant, and a machine tool plant. External post war damage to these industries was light and [redacted] no appreciable change in status. A bombing run over the Jaydepur Machine Tool Plant caused damage to a large manufacturing building and a support building, (Figure 31). Two buildings in the inert components processing area of the adjacent Dacca Ammunition Loading Plant were also damaged (Figure 32). The Bheramara Thermal Power Plant Ganges Kobadak and a jute mill located at 23-49-25N 093-34-40E on the east bank of the Lakhya River received extensive structural damage. Little or no evidence of repair was discernible at any of these plants.

Name	Coordinates	Status
Beheramara (1) Thermal Power Plant Ganges Kobadak	24-02-48N 089-02-00E	One large plant building badly damaged
Jute Mill (2)	23-49-25N 093-34-40E	Four buildings badly damaged
Dacca Ammunition Loading (3) Plant (see Figure 31)	23-53-15N 090-24-35E	Two buildings in inert components processing area damaged
Jaydepur (4) Machine Tool Plant (see Figure 32)	23-52-50N 090-24-05E	One large manu- facturing building and one support building damaged
